Wassersparmaßnahmen und Nebenwirkungen

Water-saving activities and their side effects

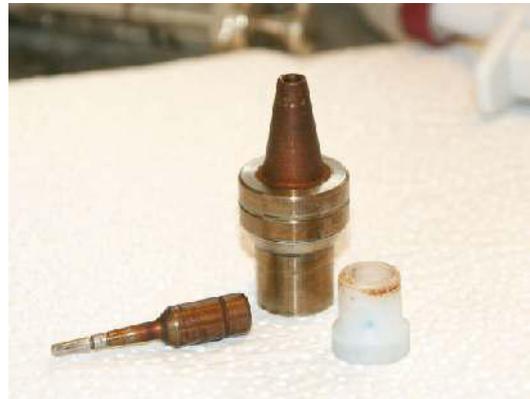
Seit einigen Jahren werden stetig steigende Schäden an Hochdruckpumpen, besonders an Ventilen und Dichtungen, beobachtet. Oft haben die beschädigten Teile eine deutlich rotbraune Farbe angenommen und sehen 'verrostet' aus (Abb.1).

Abb.1: Ventil aus einer Hochdruckpumpe.

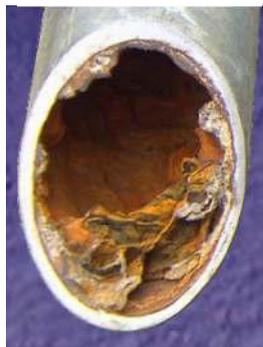
Abb.2: stark korrodiertes Rohr im Querschnitt.

Wegen der verringerten Abnahmemengen bilden sich in den jetzt überdimensionierten Ver- und Entsorgungsleitungen durch die Verringerung der Fließgeschwindigkeit Ablagerungen an den Rohrwänden. Dort siedeln sich gern hartnäckige Biofilme an, wodurch die Verkeimungsgefahr des Trinkwassers stark ansteigt. Zusätzlich findet unter der Oberfläche derselben Ablagerungen eine verstärkte Korrosion der Leitungen statt (Abb.2).

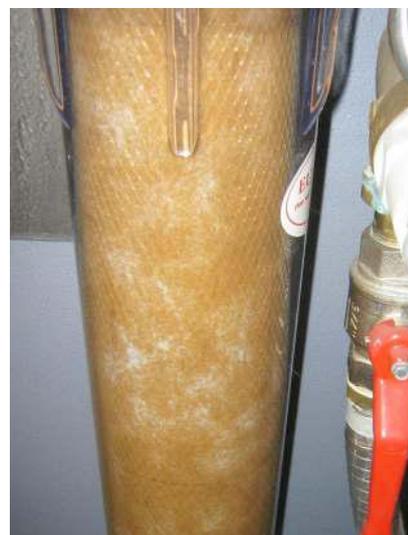
Abb.3: Rotbraune Vorfilter sind sichere Indikatoren für Schäden durch Korrosionsverschmutzung.

In der Praxis bedeutet das: immer wenn Sie einen braun verfärbten Filter vorfinden, können Sie davon ausgehen, daß etwa dieselbe Menge an Eisenverbindungen, die Sie im Filter sehen, in gelöster Form in Ihr Hochdrucksystem gelangt ist.

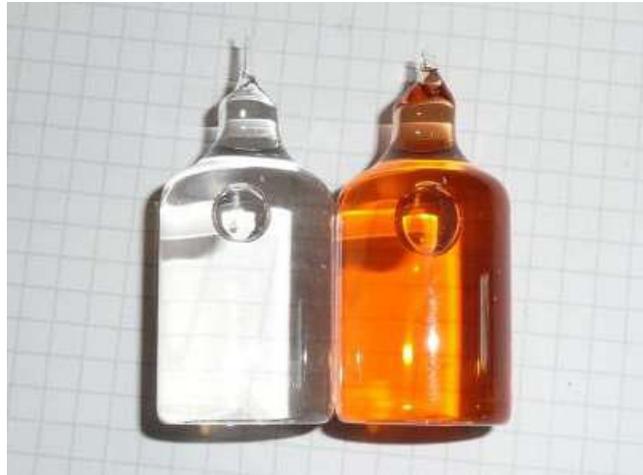
Abb.4: zwei Küvetten eines Eisen-Schnelltests, die bei einem Kunden an derselben Entnahmestelle gefüllt wurden; während der Woche (links) und am Montagmorgen (rechts). Die Intensität der Färbung zeigt den Eisengehalt an.

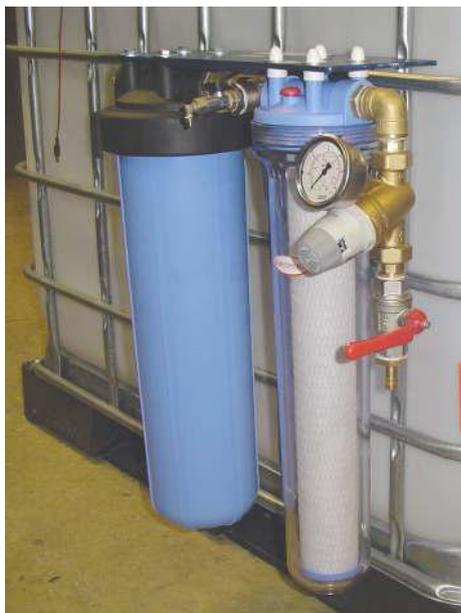
Abb.5: Filterarmatur zum Schutz vor Korrosions- Schmutzschüben, einbaufertig zur Selbstmontage.

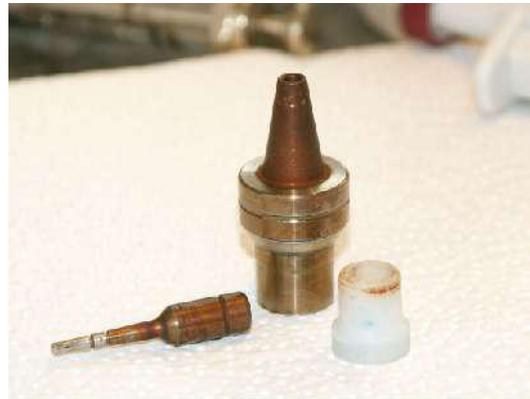
Over the last two years, steadily increasing damages at high pressure pumps, especially at valves and seals, have been perceived. Often, damaged parts have taken on a distinctly reddish-brown colour and look 'rusty' (Fig. 1).

Fig.1: valve of a high pressure pump.

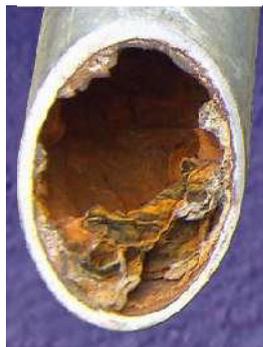
Fig.2: heavily corroded tube in cross section.

Because of the reduced consumption quantities, deposits caused by the reduced flow rate occur in the now oversized supply and disposal pipes. Persistent biofilms evolve and the germination hazard to the drinking water rises sharply. Additionally, the corrosion of the pipes increases under the surface of these deposits (Fig. 2).

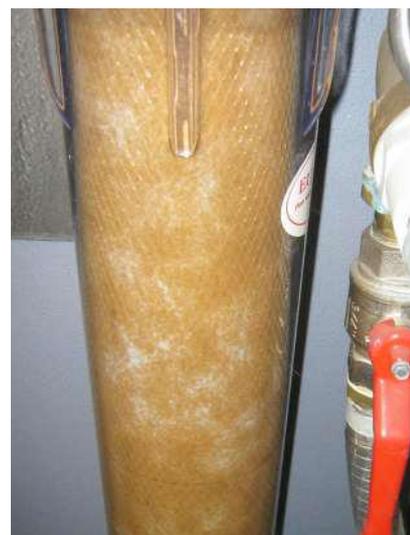
Figure 3: Red-brown pre-filters are certain indicators for damage caused by corrosion contamination.

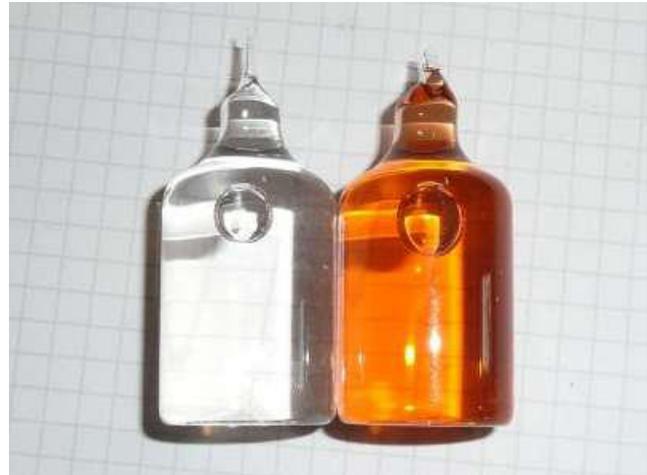
Figure 4: Two vials of an iron rapid-test, filled by a customer at the same sampling point; during the week (left) and on Monday morning (right). The intensity of the color indicates the iron content.

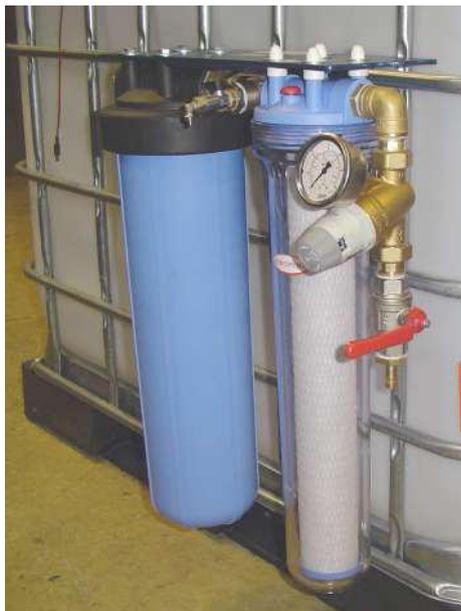
Fig.5: filter armature for protection against corrosion dirt thrusts, ready to install for self-assembly.

For the removal of dissolved iron dust (iron and monovalent ionic iron), special oxidation procedures are necessary which convert these forms into solid (bi- and trivalent) iron compounds (Fe_2O_3 , Fe_3O_4) which then can be filtered out.
